Assessment of Gurnee Path

Prepared By Jim Fisher
Hancock County Planning Commission
395 State Street
Ellsworth, ME 04605
207-667-7131
jfisher@hcpcme.org

Prepared: 11/12/2010

To determine the feasibility of rehabilitating the Gurnee Path as an alternative route for walking and bicycling between Hulls Cove and the Bar Harbor village.

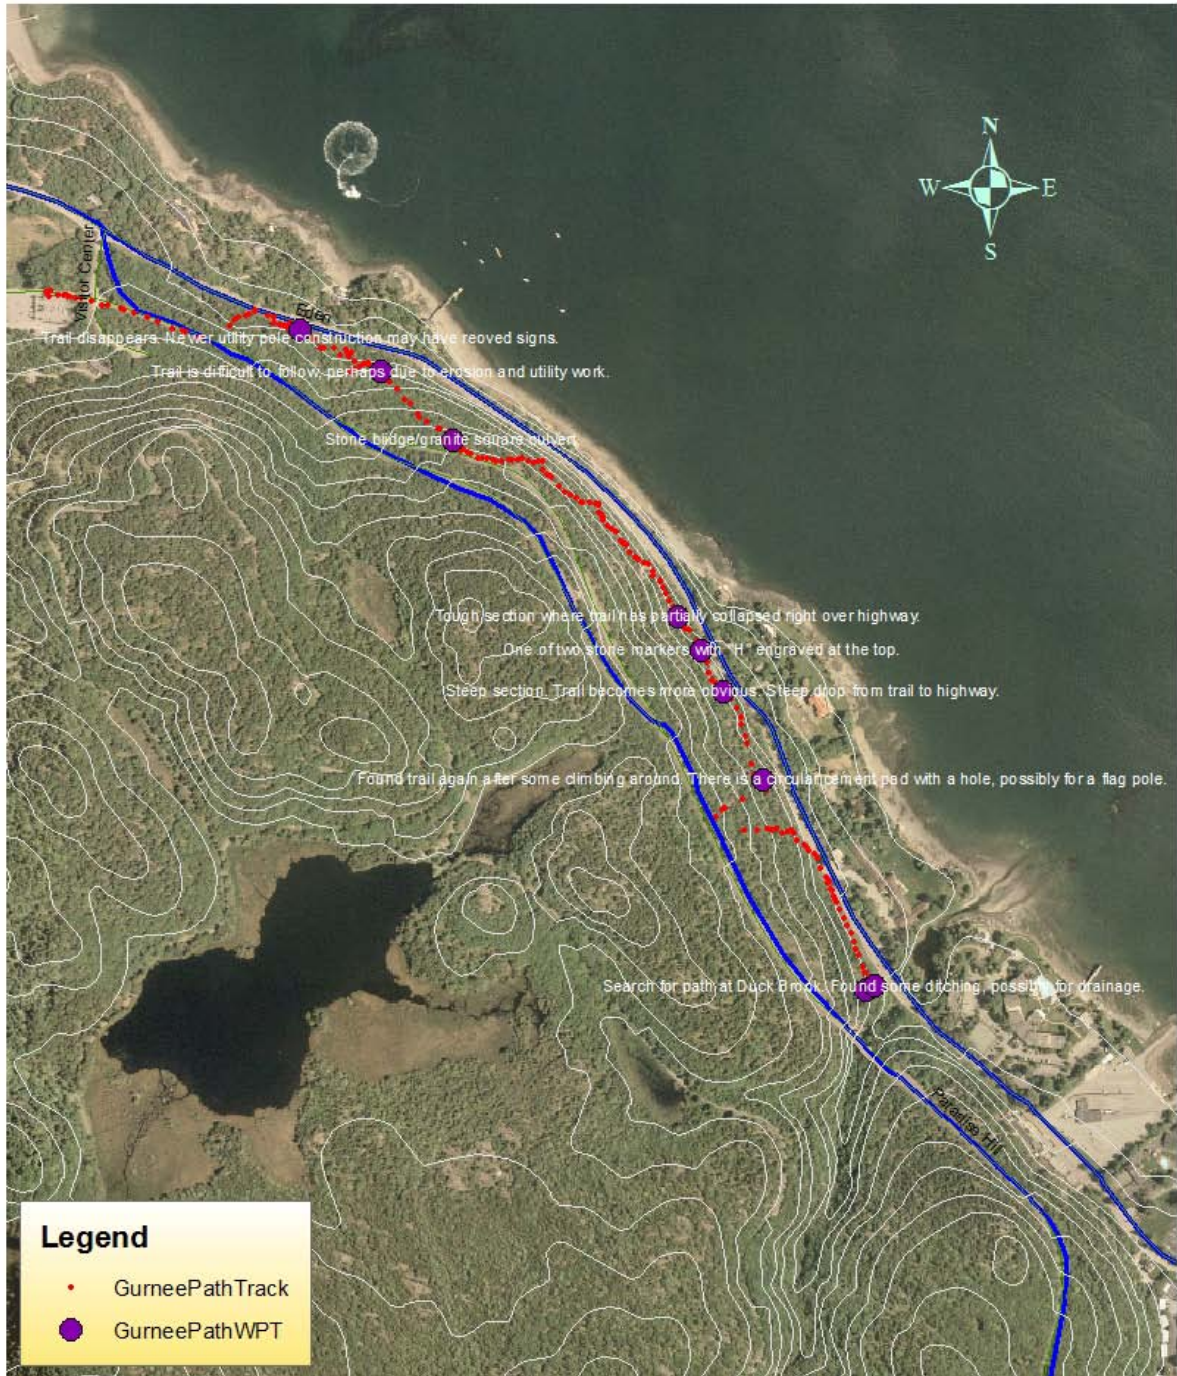
Acadia Byway Gurnee Path

I transferred the photographs to a computer and overlaid the GPS track in ArcGIS along with 2005 aerial photos, contour lines and the road network. The map that follows indicates the trail portion of my walk. All conclusions are based on my visual inspection during the walk, but are informed by the contours of the land and other geographic information.

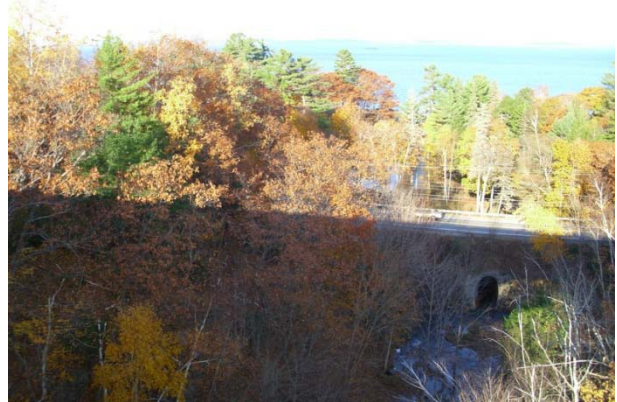
As indicated by the map below, Duck Brook presents a significant barrier to any travel other than on Route 3 or the Park Loop Road.

- Duck Brook is a major obstacle to trail development south to the village.
- The southern "ditch" section can be reshaped into a trail, with significant work removing trees, leveling the ditches and creating a new trail base.

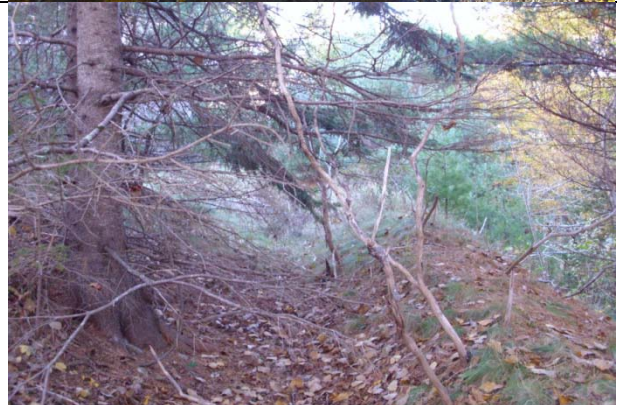
Drainage Ditches

From this southern point there appear to be two ditches that run parallel to Route 3 and may have been constructed to drain water toward Duck Brook. These ditches might be shaped into a trail if the trees growing in and around them are removed and significant earthwork and trail building ensue.

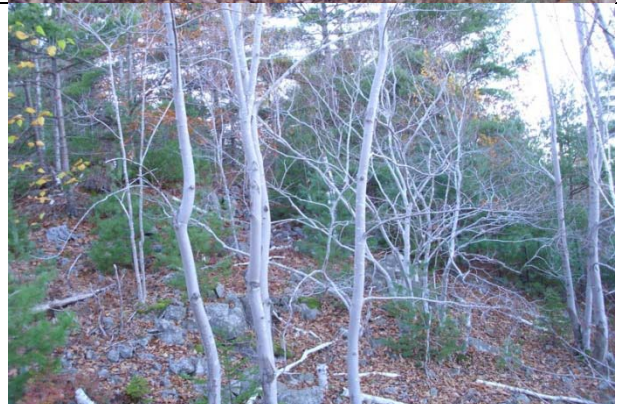
Rocks and Woods'

The ditches fade away, and no apparent trail can be found. The landscape is still undulating with rocks and mixed vegetation. A trail could be constructed through much of this area, though typically the trail would be skirting the side of the hill.

- The rocks and woods section has traverses gentle slopes and could be shaped into a trail, but drainage along this section would be a concern.
- The ascent and steep sections of the bluffs would be a very significant challenge. Insuring safe passage, particularly for bicycles, would require straitening the trail, reinforcing and paving along the shelf in the bluffs, installation of railings and systems for trapping dislodged rocks.
- The stone bridge and north sections appear feasible, though one private house is in the course of the path unless the travelers ascend to the Park Loop Road or drop down to Route 3.

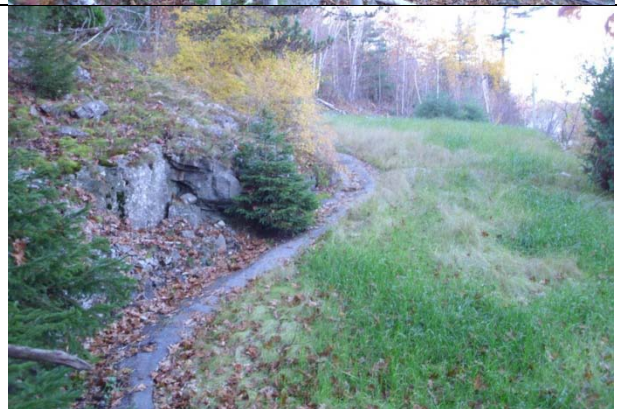
Serpentine Path to Foundation

The woods give way to an open field with a narrow serpentine paved path or drainage gutter that leads to granite steps and a small foundation.

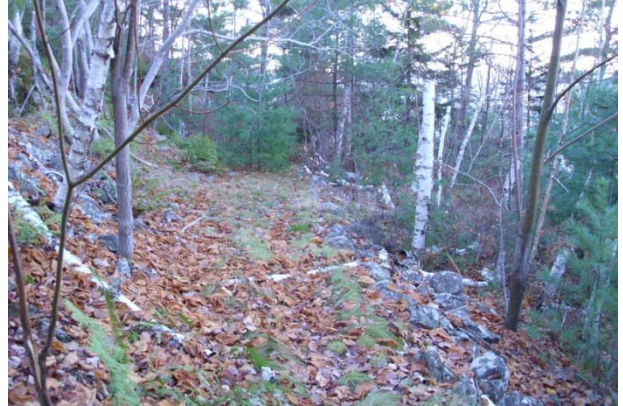
"H" Markers and Constructed Trail

After the foundation, two markers with the letter H are visible. The trail becomes more apparent. Much of it is deteriorated, but consisted of stonework along the left and right side. The trail is approximately 5 to 8 feet in width passing through relatively gentle slopes. Some sections are more obscured, but reconstruction as a walking trail would be possible.

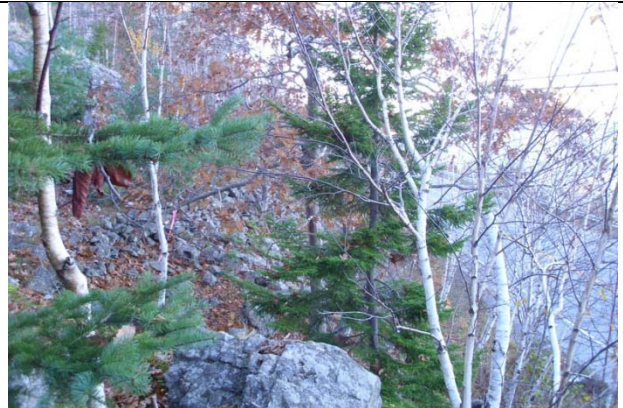
Assent

The trail now approaches the steeper section of the bluffs area. The trail ascends at approximately 15 degree slope to a midpoint along the bluffs where a natural shelf occurs. The construction elements of the trail are much more visible throughout the steeper section.

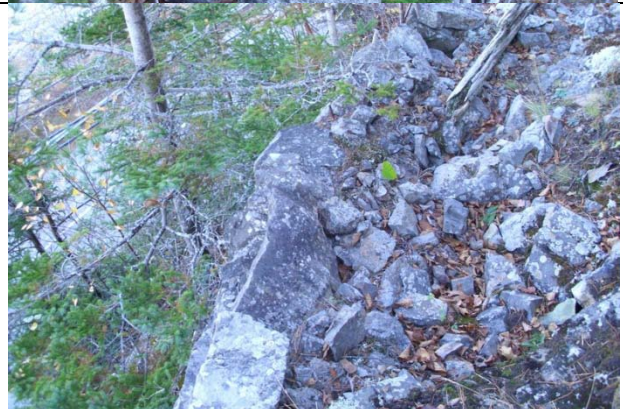
High Point

The trail reaches the shelf and continues north with a slope down to the highway approaching 70%. Any rocks dislodged in this section have a reasonable chance of landing on the road shoulder or in the road itself.

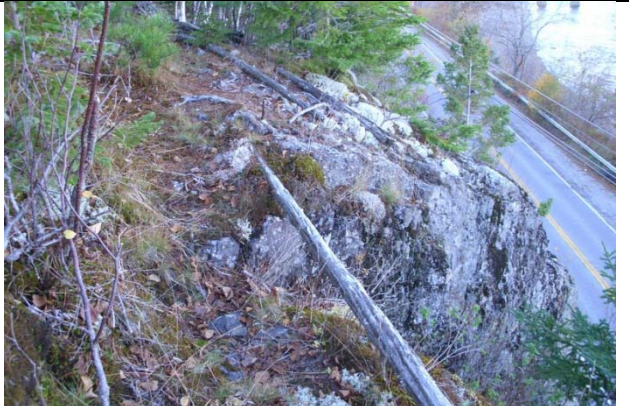
<p>Washout</p> <p>Sections along this shelf that have collapsed. This photo indicates one of the more precarious locations where the walker is skirting a vertical drop above Route 3 on a trail about 2' wide. Here too rocks would fall close to the highway.</p>

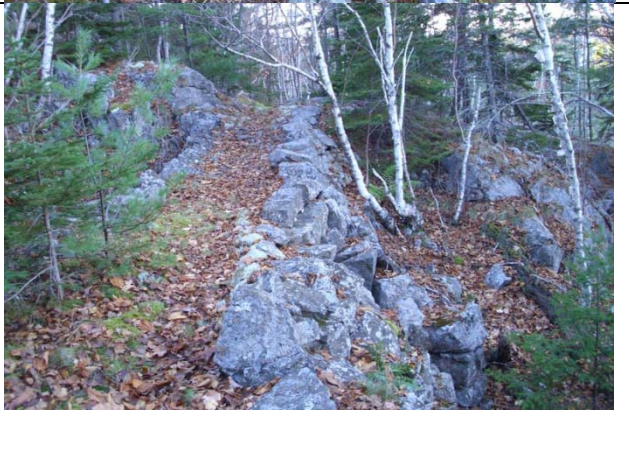
<p>Stone Bridge</p> <p>North from the steep shelf, the trail returns to a gentle slope with some interesting remains of the original construction. This photograph shows a small stone bridge over a seasonal stream. The bridge is a nice piece of work, though it would not be wide enough for bicycles.</p>

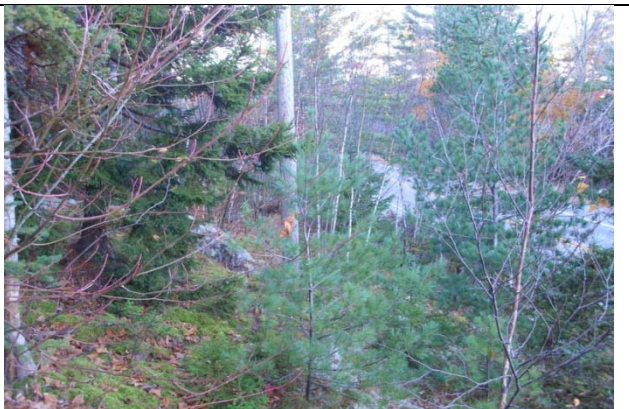
<p>Utilities and End of the Line</p> <p>Shortly after the stone bridge the trail appears to disintegrate. It is possible that it ends here, but it also is possible that installation of utilities resulted in removing a section of the trail. I circled the area without finding ongoing trail. From here is about 30 feet of 30 degree slope down to Route 3. This dropping off point is .2 miles from the Park Visitor Center entrance road.</p>
